# INVESTIGATING THE POTENTIAL IMPACTS OF THE ARABIAN MINE ON WIDENING OF SR 68, MOHAVE COUNTY, ARIZONA

Robert Cummings, P.E., Saguaro GeoServices, Inc.<sup>1</sup>

Nick Priznar, Arizona Department of Transportation<sup>2</sup>

Interstate Technical Group on Abandoned Underground Mines, Tucson AZ , April, 2004

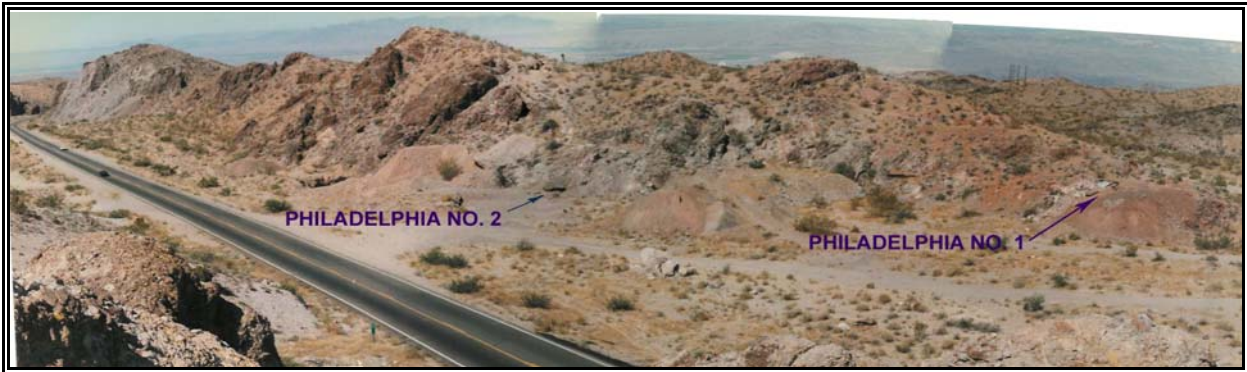
**Figure 8 – Panoramic view of Arabian Mine site with realigned curve at extreme left**

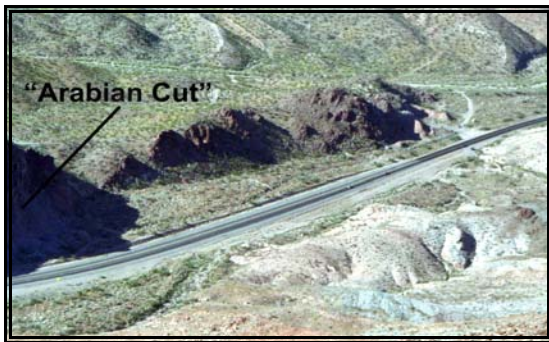
Also, in 1934-1935, gold was recovered from a surface operation known as the Arabian Cut, on the Rising Fawn claim a little over 1,000 ft south of the underground workings, opposite the future curve realignment (Figure 9). According to the Arizona Department of Mineral resources in a report dated October 9, 1940, some development took place in the Philadelphia No. 1 shaft by new owners.

**Figure 9 – Arabian Cut**

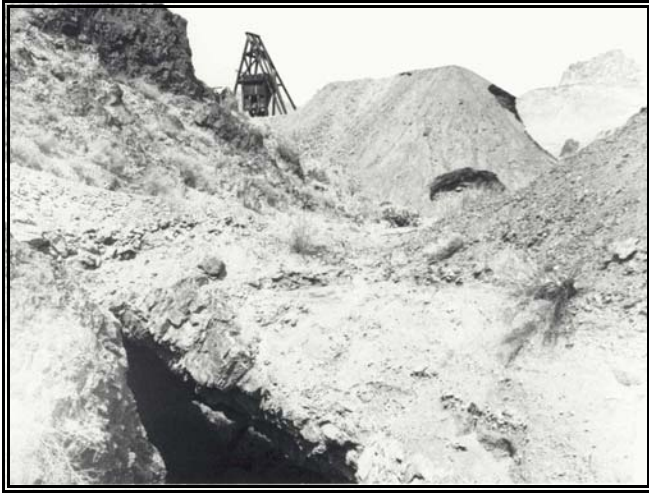
By the time ADOT commenced its studies, open stopes and shafts had stood for decades; some had remained open since the mine's period of active operation (compare Figures 12 and 13, next page), with remarkably few changes. Fencing of these very hazardous openings had deteriorated to where it was almost totally ineffective in denying casual public access, so ADOT installed chain link fencing and razor wire to mitigate the hazards.

**Figure 12 – 1930s view of stope and headframe**

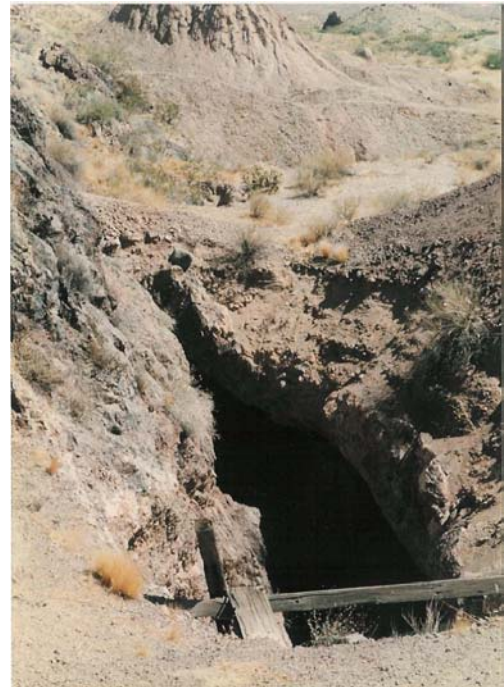
**Figure 13 – 1990s view of area in Figure 12**

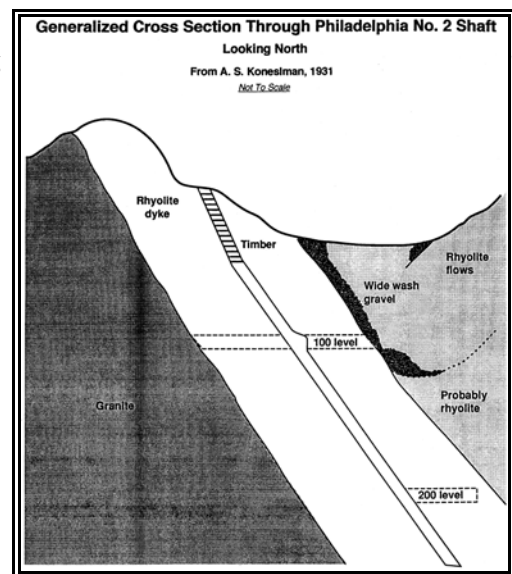
The mine was developed along a steeply-dipping rhyolite dike that intruded an older granitic mass, apparently along a significant fault zone. The shallower portions of the hanging wall of the dike contact gravel fill that comprises the adjacent wash (see Figures 14 and 7). Inasmuch as the wash drains a considerable portion of the surrounding upland terrain, the mine was wet during the period of operation, reportedly making about 35 gpm. Even today, most of the old workings are flooded; the mine pool can be seen from the surface in some open stopes. Lausen's (1931) description of the Arabian Mine geology was referenced for the study since most of the underground workings are inaccessible:

The deeper portions of the dike hanging wall are in fault contact with porous rhyolite tuffs. The mineralized zone reportedly averaged about 30 ft wide, chiefly within the dike but also extending into the granite footwall, consisting of quartz stringers. Although Lausen notes that the Arabian vein dips 82 degrees overall, the inclinations of the main production shafts, the Philadelphia No. 1 and Philadelphia No. 2, do not match the steep inclination of the vein, but have a shallower slope in their accessible reaches.

**Figure 14 – Conceptual cross section through Arabian vein**

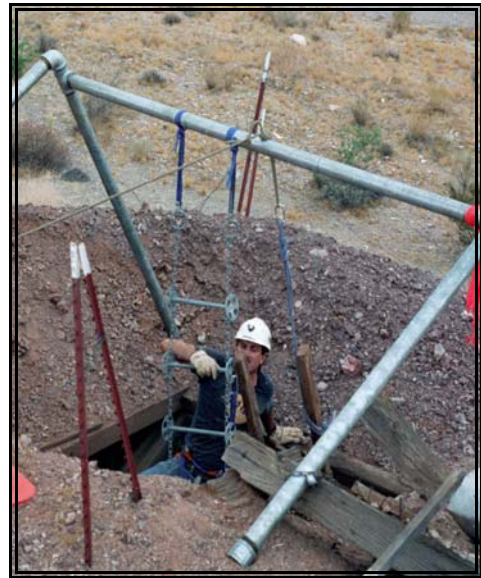
Subsurface access was obtained using ship's ladders. At the Philadelphia No. 1 Shaft, the ship's ladder was hung over a pipe framework placed over the shaft collar (Figure 17). The Philadelphia No. 1 shaft collar timber was found to be in good condition. Hazardous old ladders and other debris were hoisted out of the shaft and discarded. The ladders were later destroyed to prevent unauthorized replacement of these hazards into the shaft. At the Philadelphia No. 2, there was no safe way to set the pipe framework without disturbing an old timber loading platform and the debris atop it, (Figure 18) so pins were set at the collar to affix the shaft ladder at the surface. Concern for damaging the shaft collar timber, and the very limited working room around the collar, prevented more than 35 ft of ship's ladder from being lowered into the Philadelphia No. 2. Further access had to be gained by climbing down the old steel rail in the shaft which would not accommodate the transport of gear needed for deeper ventures. This limited the investigation of the No. 2 shaft workings to those that were horizontal, continuous, and accessible by foot.

**Figure 17 – Accessing the Philadelphia No. 1 shaft and removing hazardous ladders**
